Manhole Inspection Summary

Manhole # **S49K__012MH**

Insp Date: **3/27/08 1:34 PM**

Location Address: **700 S Glover Lakewood**

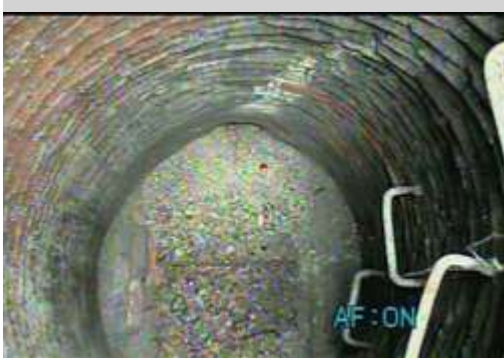
Defect 2

Condition: ☐ Sound ☐ Cracked ☐ Root Intrusion ☐ Deteriorated ☐ Leaks ☒ **Debris**

channel debris

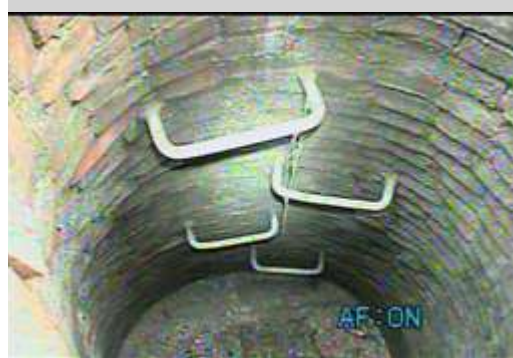
Defect 1

Count: **4** Missing: **0** ☒ **Corroded**

corroded steps

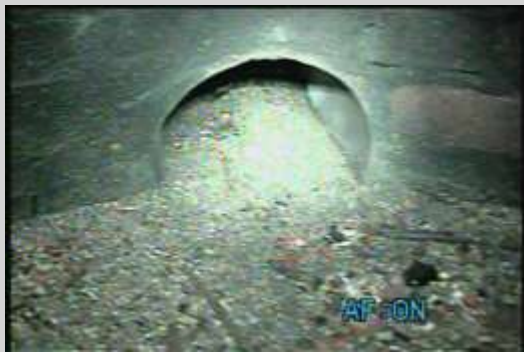
12 O'Clock Outflow

8 in. Circular Gravity Sewer
Pipe Out @ 12 O'Clock

Deposits: ☐ None ☒ **Mud** ☐ Sludge ☐ Debris ☐ Grease

Silt Depth: **2** (in.) Deposits Extent: **Medium**
